City of Brookings Curry County, Oregon

FERRY CREEK FEASIBILITY STUDY 2018

The Dyer Partnership Engineers & Planners, Inc.

Project No. 145.80

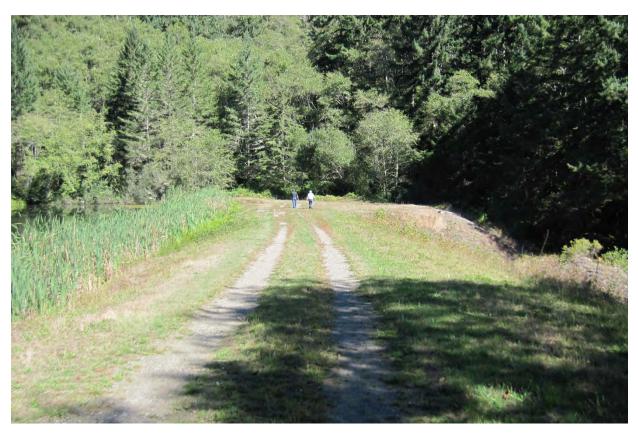
Photo 1B. View of the dam crest looking northeast from the southern end.

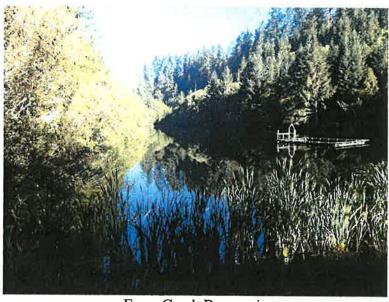
Ferry Creek Reservoir

The reservoir level was 3-feet below the dam crest when inspected. Minimum freeboard was 2-feet, which is unsafe. The reservoir was fairly clean, with no large floating logs. The photo above shows, what is believed to be, the inlet structure for the conduits. It is unknown if this is operational.

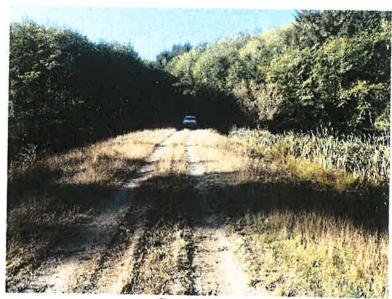
Crest of dam

The crest of the dam also serves as road access across the dam. The surface is moderately rutted. I observed no sign of recent slope movement on the crest or either face of the dam. Inspection for animal damage was limited by heavy cattail cover on the upstream face.

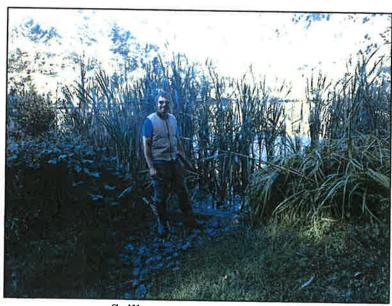
Spillway approach channel

There was moderate growth of vegetation at the spillway approach. This restricts flood flow into the spillway.

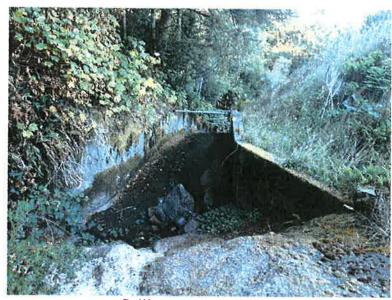
Spillway control section

The spillway control section appears very narrow for passage of a probable maximum flood, which is the design standard for a high-hazard rated dam. There are significant defects in the concrete control part of the spillway, as shown in the next photo.

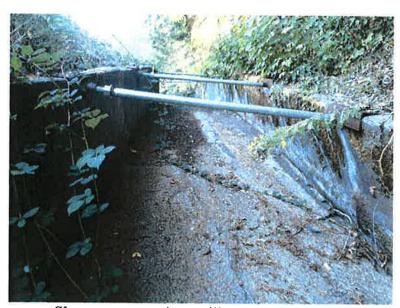
Slope movement into spillway control section

The hillslope adjacent to the spillway has, at some point, moved towards the spillway control section. Struts have been placed and may be reducing or temporarily controlling slope movement. Additional movement is a very real possibility, and such movement would greatly compromise ability of the spillway to pass flood flow.

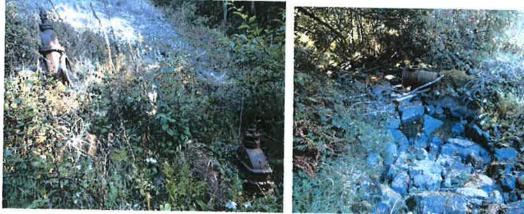
There are multiple conduits that penetrate through this dam. This is very atypical. Each conduit provides a potential location for leakage into the dam. It also appears that these pipes, with valves on the downstream side, may very well be pressurized. There was no opportunity to inspect the conduit, since the upstream end was submerged and the downstream end was buried and connected to the pressurized irrigation system. A conduit is pressurized when the control valve is at or below the outlet of the dam, instead of in the reservoir on the upstream face. Most dams are designed for gravity flow, not for pressurized conduits. Conduits are pipe, and depending on the type of pipe and the age of the pipe, risk of high-pressure leakage exists in a pressurized system. In an earthen dam, this high pressure water can cause severe internal erosion, and this can result in rapid dam failure.

Intermediate and bottom valves

To date, I had not inspected an embankment dam with many penetrating conduits. It may not be possible to make the dam safe with penetrating conduits.

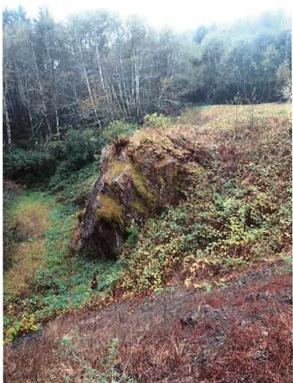
Vegetation on the downstream slope, right abutment and toe of the dam

The reservoir level was 3.1 feet below the dam crest when inspected. Minimum freeboard was 2.1 feet, which is potentially unsafe due to the condition issues with this dam. On the dam crest, soil has settled and created a low spot which lowers the total reservoir storage by approximately 2.4 feet.

Low spots on the dam crest are typical of older earth fill dams and occur as a result of crest movement due to settlement or compaction of the soil material. Settlement occurs naturally overtime through settlement of the soil particles while compaction occurs through animal or human activity. Low spots on the crest reduce the minimum freeboard which can increase the potential for overtopping of the dam during a significant storm event. Overtopping of the dam can lead to a catastrophic dam failure.

There is also a significant amount of vegetation on the downstream face, left and right abutments, and toe of the dam. Extensive vegetation prevents complete inspection of the dam surface and outlet control works. Visual inspection makes it possible to identify any deficiencies that may lead to unsafe operation of the dam; it is a critical component of a dam safety inspection. Common issues identified through visual inspection are embankment stability and movement, seepage, animal activity, poor condition of penetrating conduits, and lack of functionality of the outlet works.

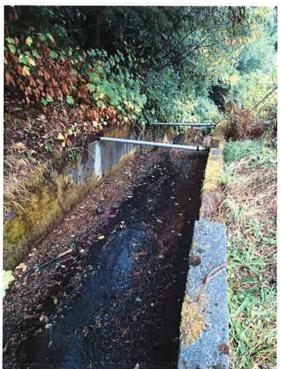
Steel struts preventing spillway channel retaining wall failure

Based on measurements taken during our inspection, the spillway appears to be undersized for a moderately sized storm event. It should be noted that the only definitive means to determine if the spillway is truly undersized, is through a detailed engineering analysis. However, our rough calculations indicate that there is enough reason for concern regarding the spillway capacity without the need for a full engineering analysis at this time. Consequently, it is extremely likely that in a moderately sized storm event the dam will be overtopped, possibly leading to a catastrophic failure of the dam.

In addition, the retaining walls of the discharge channel for the spillway are beginning to fail. The walls are currently held in place by steel struts. These struts are located within the spillway channel and therefore present an obstruction to flow. As a result, the capacity of the spillway is reduced from the "as-designed" condition.

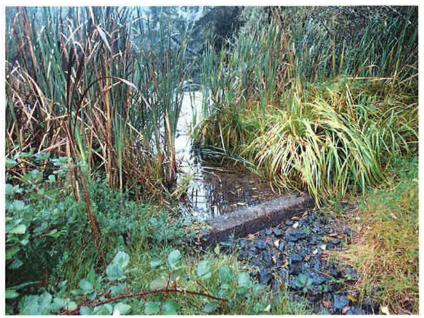
Vegetation in the emergency spillway control section

There is a significant amount of vegetation in the emergency spillway control section and channel. It also appears that there was land slide into the spillway at some point in the past. This is evidenced by the fact that the control section (shown in the image above) is partially buried and the section, in its current condition, is not uniform. It also appears that there is a significant amount of material in the discharge channel just downstream of the control section. Both the vegetation and the material from the slide obstruct flow through the spillway and therefore reduce the capacity of the spillway to pass flood flows.

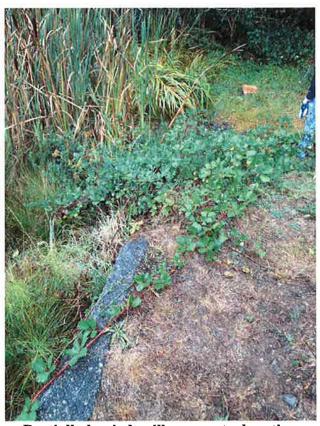
Partially buried spillway control section

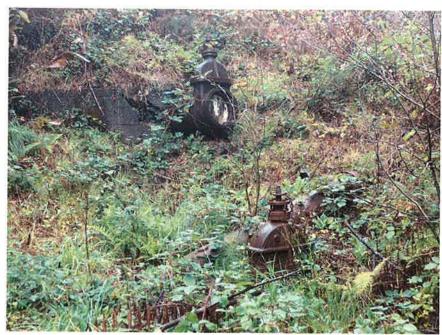
Intermediate conduits with valves

There are multiple conduits that penetrate through this dam. This is very atypical. Each conduit provides a potential location for leakage into the dam. Two of the conduits have valves on the downstream side which suggests that they might be pressurized. However, the upper intermediate conduit (upper left in the photo above) has a cracked housing so it is likely not pressurized. A conduit is pressurized when the control valve is at or below the outlet of the dam, instead of in the reservoir on the upstream face. Most dams are designed for gravity flow, not for pressurized conduits. Conduits are pipe, and depending on the type of pipe and the age of the pipe, risk of high-pressure leakage exists in a pressurized system. In an earthen dam, this high pressure water can cause severe internal erosion, and this can result in rapid dam failure. It does not appear that either of the two intermediate conduits has been used in some time.

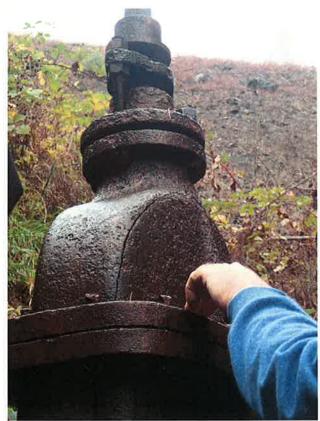
Crack in housing of upper most intermediate valve

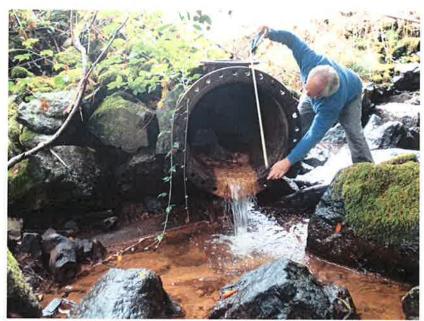
Low level conduit

There is also a low level conduit that is not pressurized. This pipe is clearly leaking at approximately 15 to 20 cubic feet per second. Either the gate valve on the upstream side is partially open or there is a leak in the upstream valve or somewhere along the conduit. We were unable to inspect the upstream gate valve because it was submerged. There are no visible controls for the low level conduit. As a result, it is not operable. A properly working outlet conduit is a key safety feature of a dam. The controls and conduit must be functional to drain the dam during an emergency.

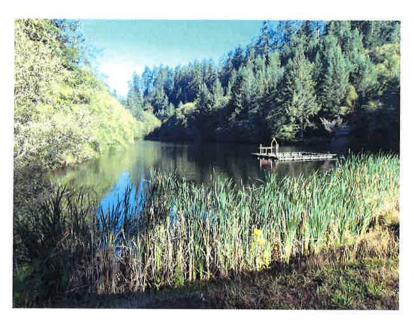
The reservoir level was 3.6 feet below the dam crest when inspected. Minimum freeboard was 2.1 feet, which is poor and makes the dam vulnerable to overtopping in an extreme rainstorm or if the spillway is partly blocked. The reservoir was mostly clean.

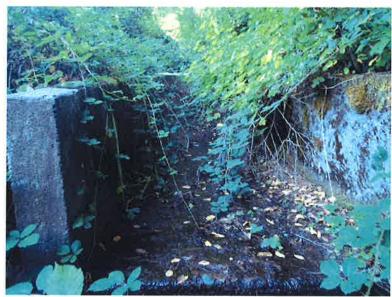
Spillway seriously overgrown

The spillway channel has been damaged by slow movement of a landslide into and under the spillway. In addition, blackberries have invaded the spillway, and there are trees encroaching at the sides of the spillway. These may further restrict flow through the spillway.

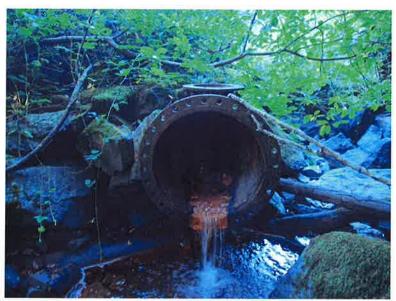
Lowest outlet pipe leaking

The flow through the lowest of the three conduits was measured at approximately 20 gallons per minute. No flow was observed in the other two conduits, however the middle conduit has a valve at the downstream end so it may be pressurized. A conduit is pressurized when the control valve is at or below the outlet of the dam, instead of in the reservoir on the upstream face. Most dams are designed for gravity flow, and not for pressurized conduits. Conduits are pipe, and depending on the type of pipe and the age of

the pipe, risk of high pressure leakage exists in a pressurized system. In an earthen dam, this high pressure water can cause severe internal erosion, and this can result in rapid dam failure. In a low pressure situation, there is little pressure available to force water into and through the embankment. Whether it is actually pressurized is unknown.

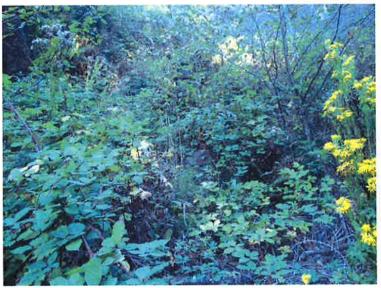
Outlet pipes overgrown

The photo above shows the other two valves almost completely overgrown by blackberries and other brush. The dense brush prevents determination of possible seepage around either pipe the brush, and makes full inspection impossible.

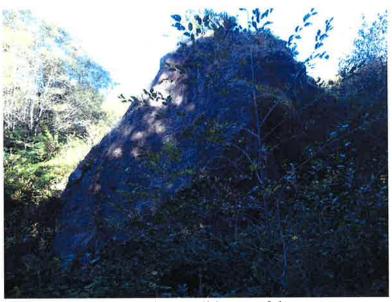
Large rock monolith part of dam

There are ongoing feasibility studies looking at options for this dam and reservoir. The site condition, including the monolith above, are atypical as compared to most Oregon dams.
