City of Brookings Curry County, Oregon

FERRY CREEK FEASIBILITY STUDY 2018

The Dyer Partnership Engineers & Planners, Inc.

Project No. 145.80

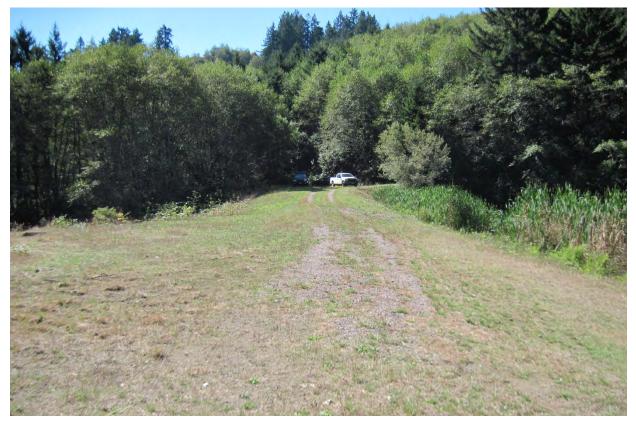
Photo 2B. View of the dam crest looking southwest from the northern end.

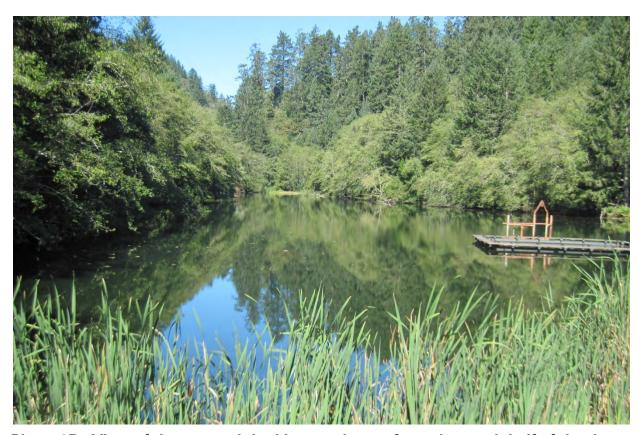
Photo 3B. View of the reservoir looking northwest from the south half of the dam.

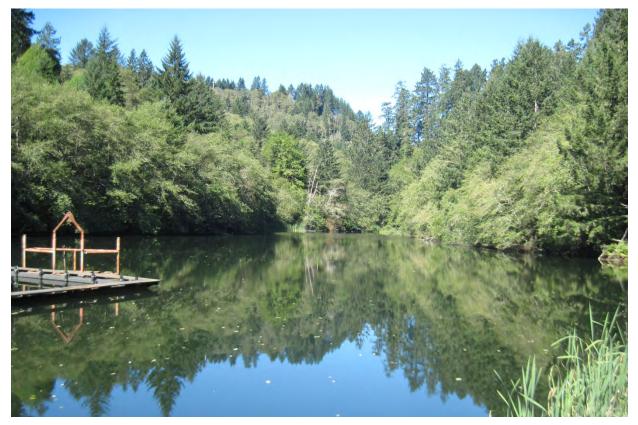
Photo 4B. View of the reservoir looking northwest from the north half of the dam.

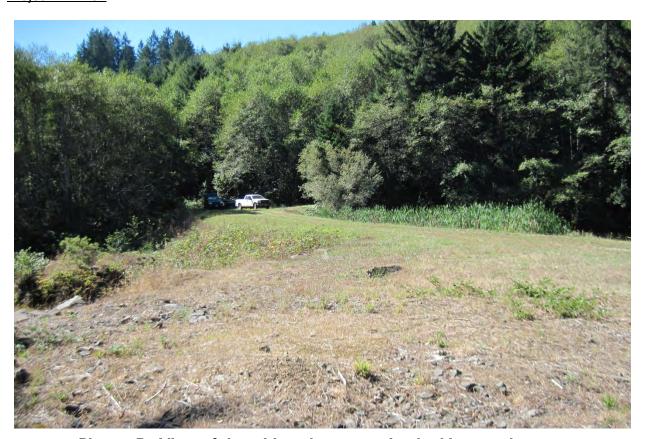
Photo 5B. View of the widened crest section looking southwest.

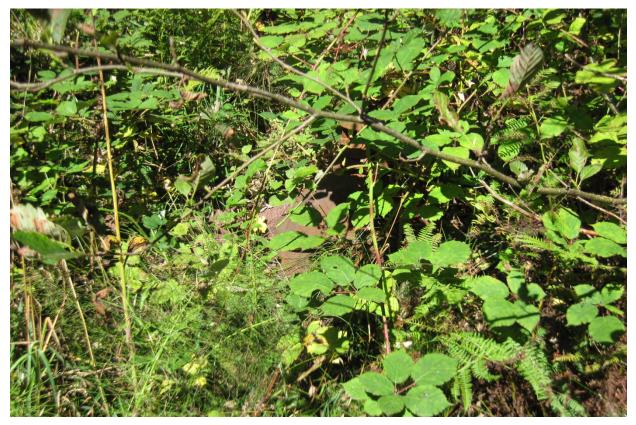
Photo 6B. Pipe exposed on the downstream face of the dam.

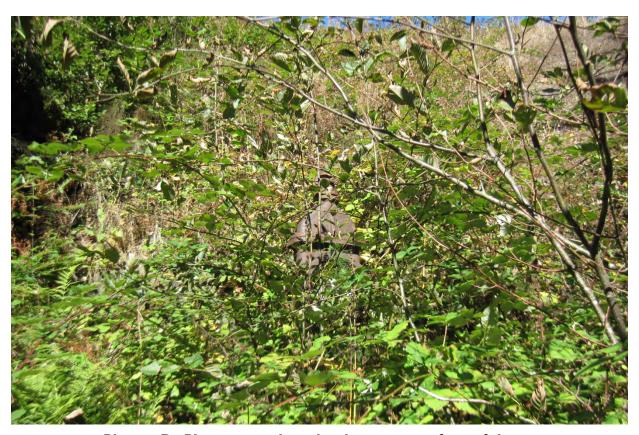
Photo 7B. Pipe exposed on the downstream face of dam.

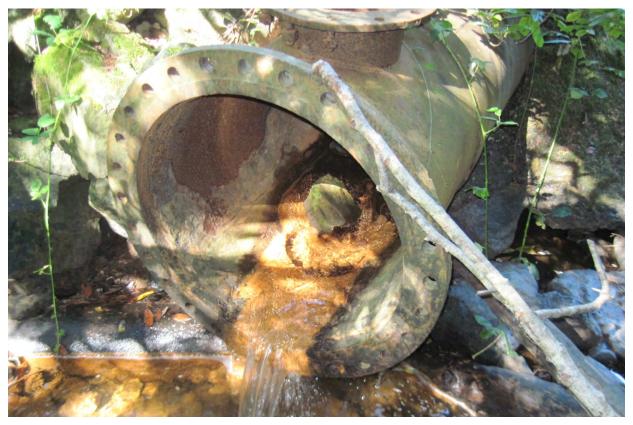
Photo 8B. Water flowing from the discharge pipe at the toe of the dam.

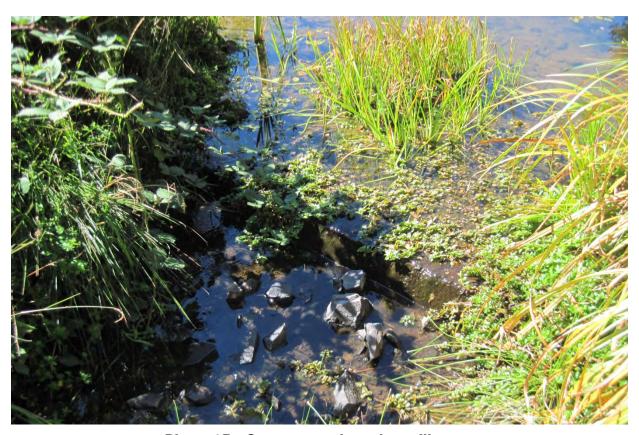
Photo 9B. Concrete weir at the spillway.

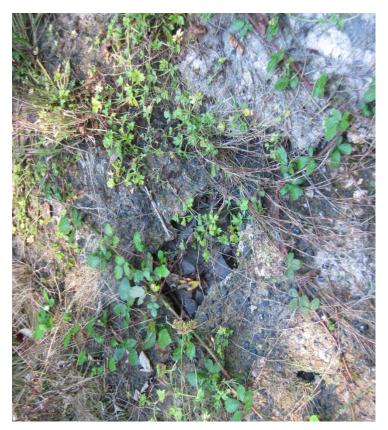
Photo 11B. Voids in shotcrete chute

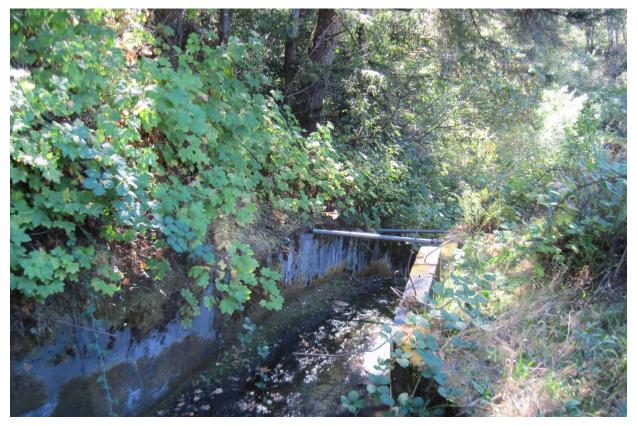
Photo 12B. Tilting and braced spillway walls looking southeast.

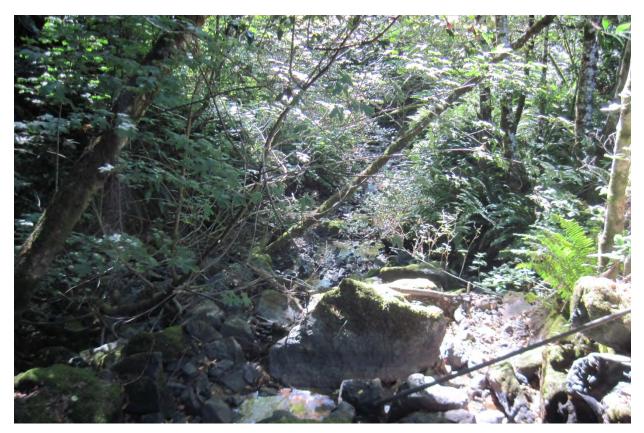
Photo 13B. Ravine below the spillway looking southeast.

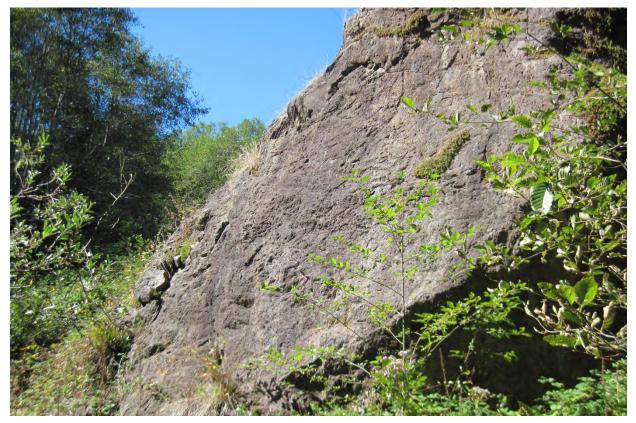
Photo 14B. Bimrock feature exposed on the downstream face of dam looking west.

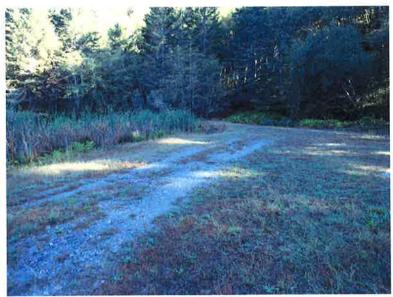
The reservoir level was 3.6 feet below the dam crest when inspected. Minimum freeboard was 2.1 feet, which is poor and makes the dam vulnerable to overtopping in an extreme rainstorm or if the spillway is partly blocked. The reservoir was mostly clean.

Low spot in crest of dam

The dam crest is much lower than the rest of the crest at the location pictured above, about 50-100 feet from the spillway. This is the reason the freeboard is so low. We do appreciate the City's inspections during heavy rain events during the winter of 2017-17. It would not take much to improve safety through movement of fill from the high sections of the dam to this location, and making a level crest.

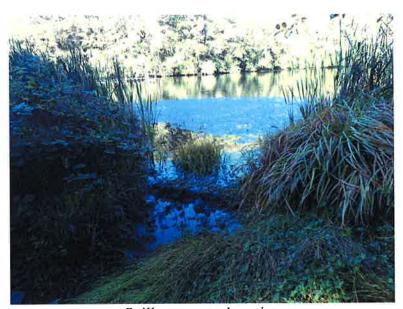
Spillway control section

There is brush, soil and cobbles on and around the concrete sill (spillway control section. It is important to keep significant obstructions out of the spillway if these obstructions reduce flow capacity through the spillway. With additional growth of vegetation this will start to be the case.
